## EXPERIMENTAL ASPHALT TEST SECTIONS ON THE NEWCASTLE AND COLFAX JOBS

FINAL REPORT

February, 1968

**NO. M & R 643230**

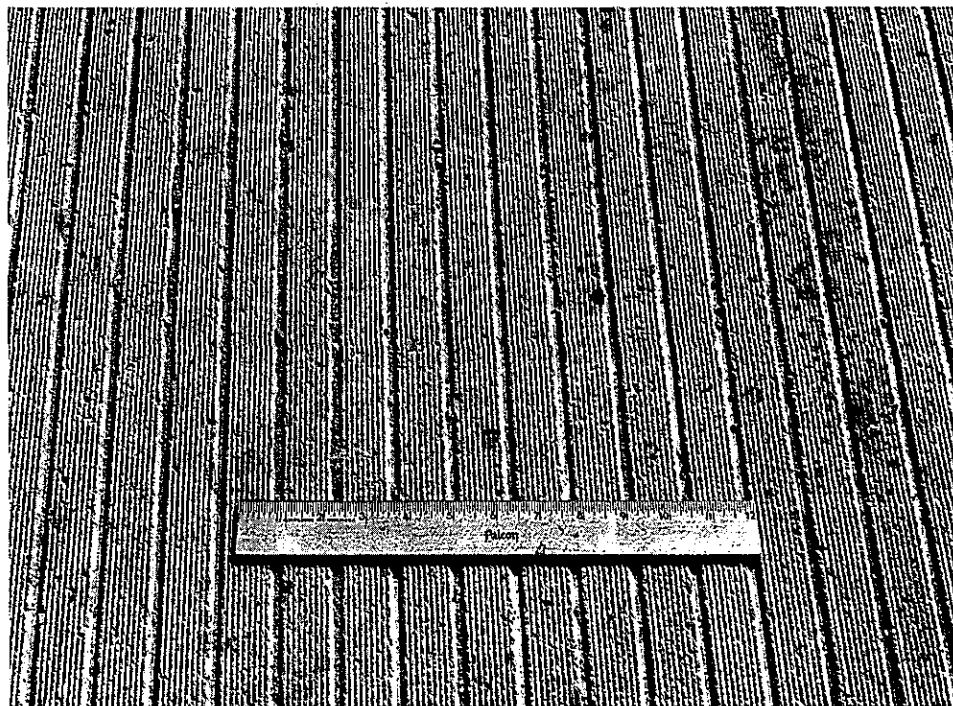
Figure 2

Photographs of Several Patterns Used on Various Projects

Rectangular Grooves

Style 15

A number of patterns have been used in our serration work to date. This was done in order to determine the increase in the friction factor, wear resistance, and possible vehicle handling problem. In all cases the grooves are all in a longitudinal direction. Figure 3 shows the patterns used on the various projects, and Table A the increase in the friction value after grooving and the change during service life. Figure 4 shows the effect of grooving on the average coefficient of friction value for the various PCC pavement projects.

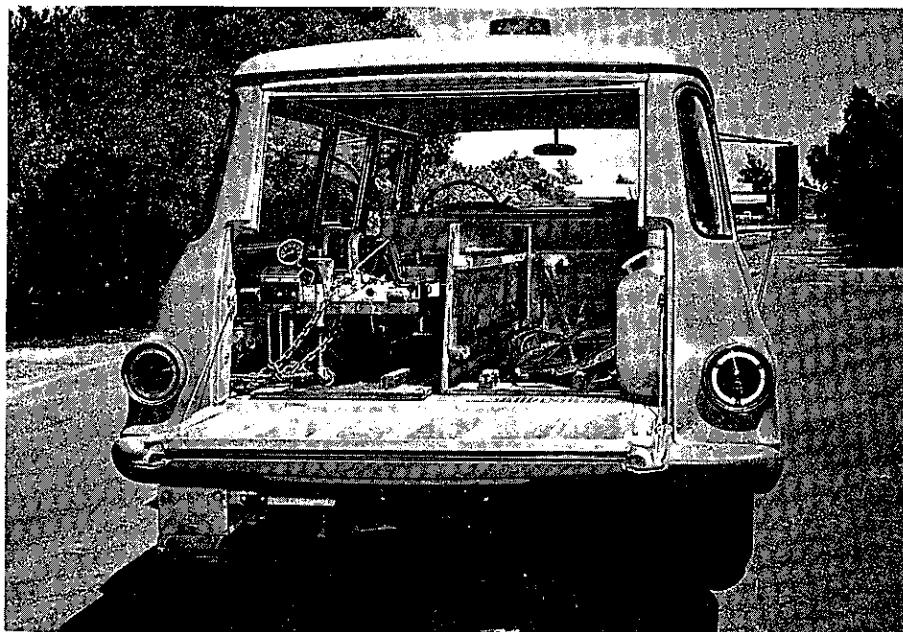
FIGURE X  
APPARATUS IN POSITION FOR TRANSPORTATION
